Abbreviated Bridge Condition Report

REGION / DISTRICT: 1 / 1

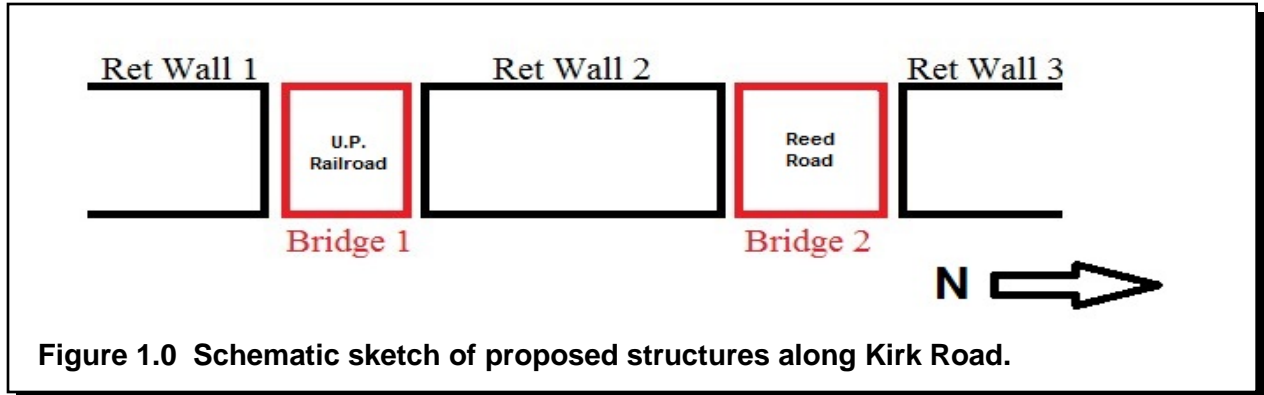
Three mechanically stabilized earth (MSE) retaining walls will be constructed to support new fill. The southernmost wall will be “U” shaped. This wall will parallel Kirk Road and will support the south abutment of the bridge over the railroad. The middle wall will be box shaped. It will parallel Kirk Road between the railroad and Reed Road and will support the north abutment on the railroad bridge and the south abutment of the Reed Road Bridge. The northernmost wall will be “U” shaped and parallel Kirk Road and will support the north abutment of the Reed Road Bridge. A schematic sketch of the bridge and wall layout can be found in Figure 1.0. The wall lengths will be further defined during the TS&L development.

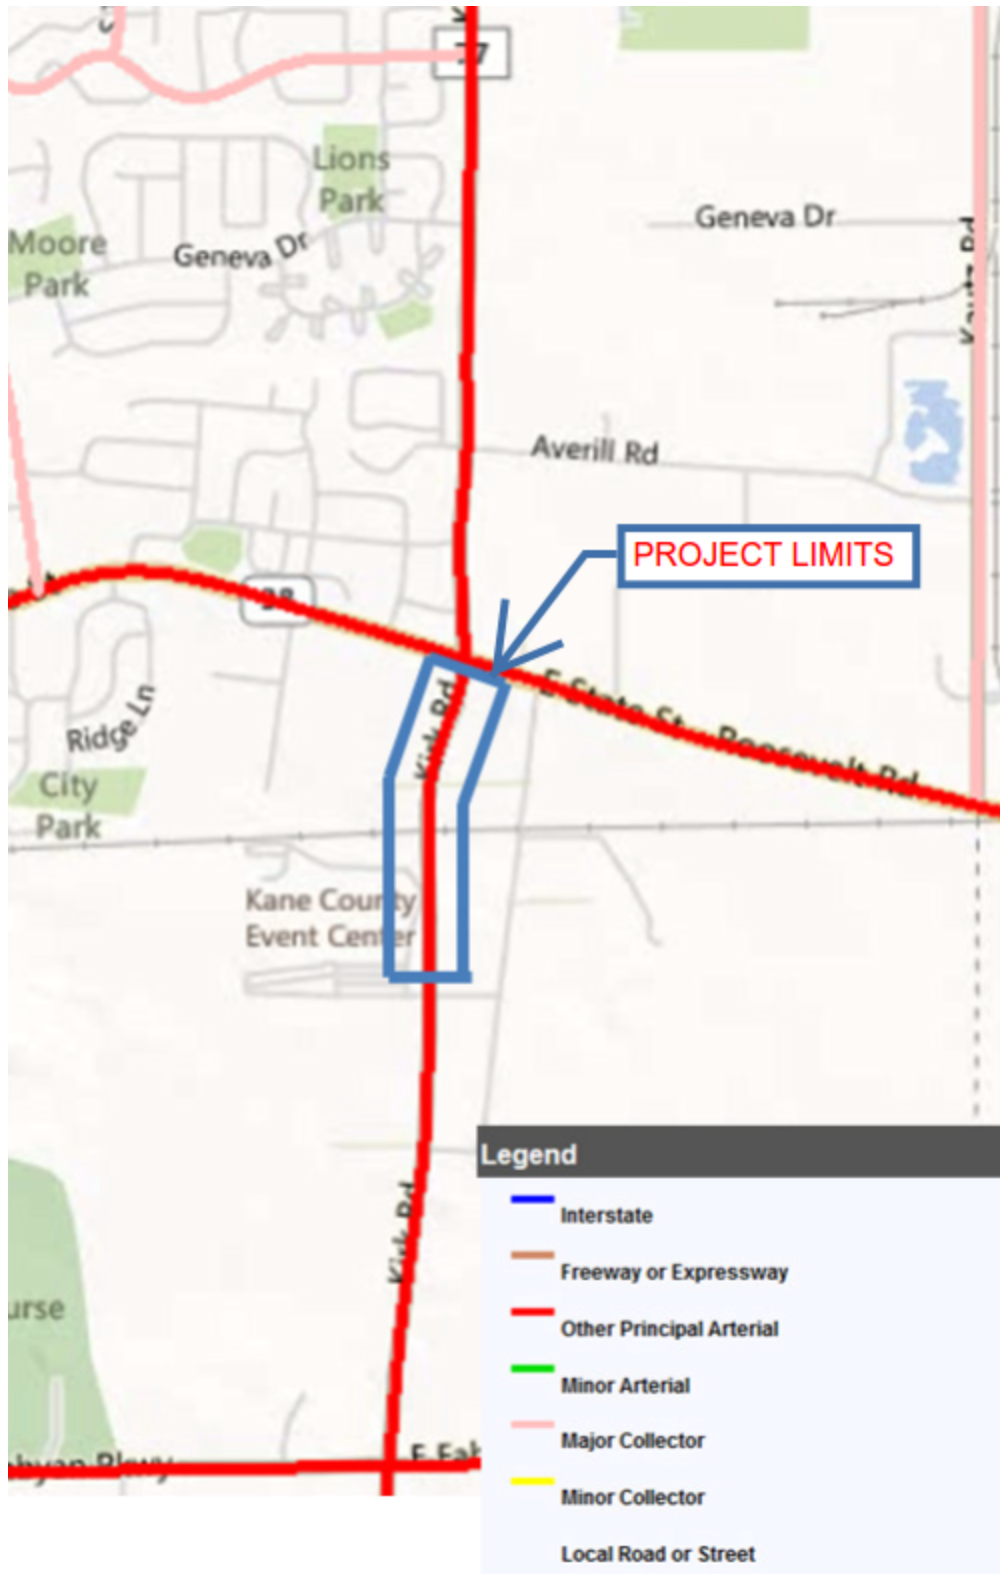
KIRK ROAD OVER THE UNION PACIFIC RAILROAD
ROADWAY CLASSIFICATION MAP

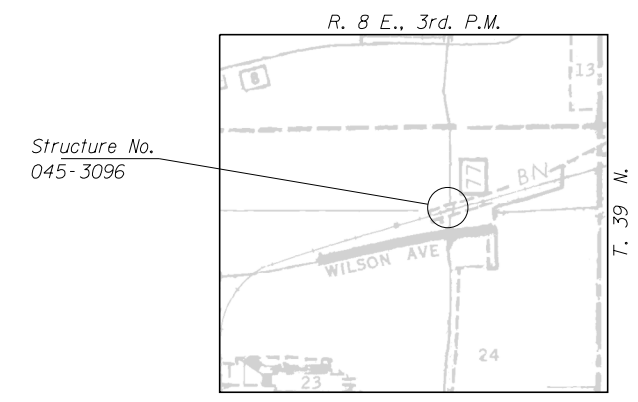
| SS = Shear Stirrup | |

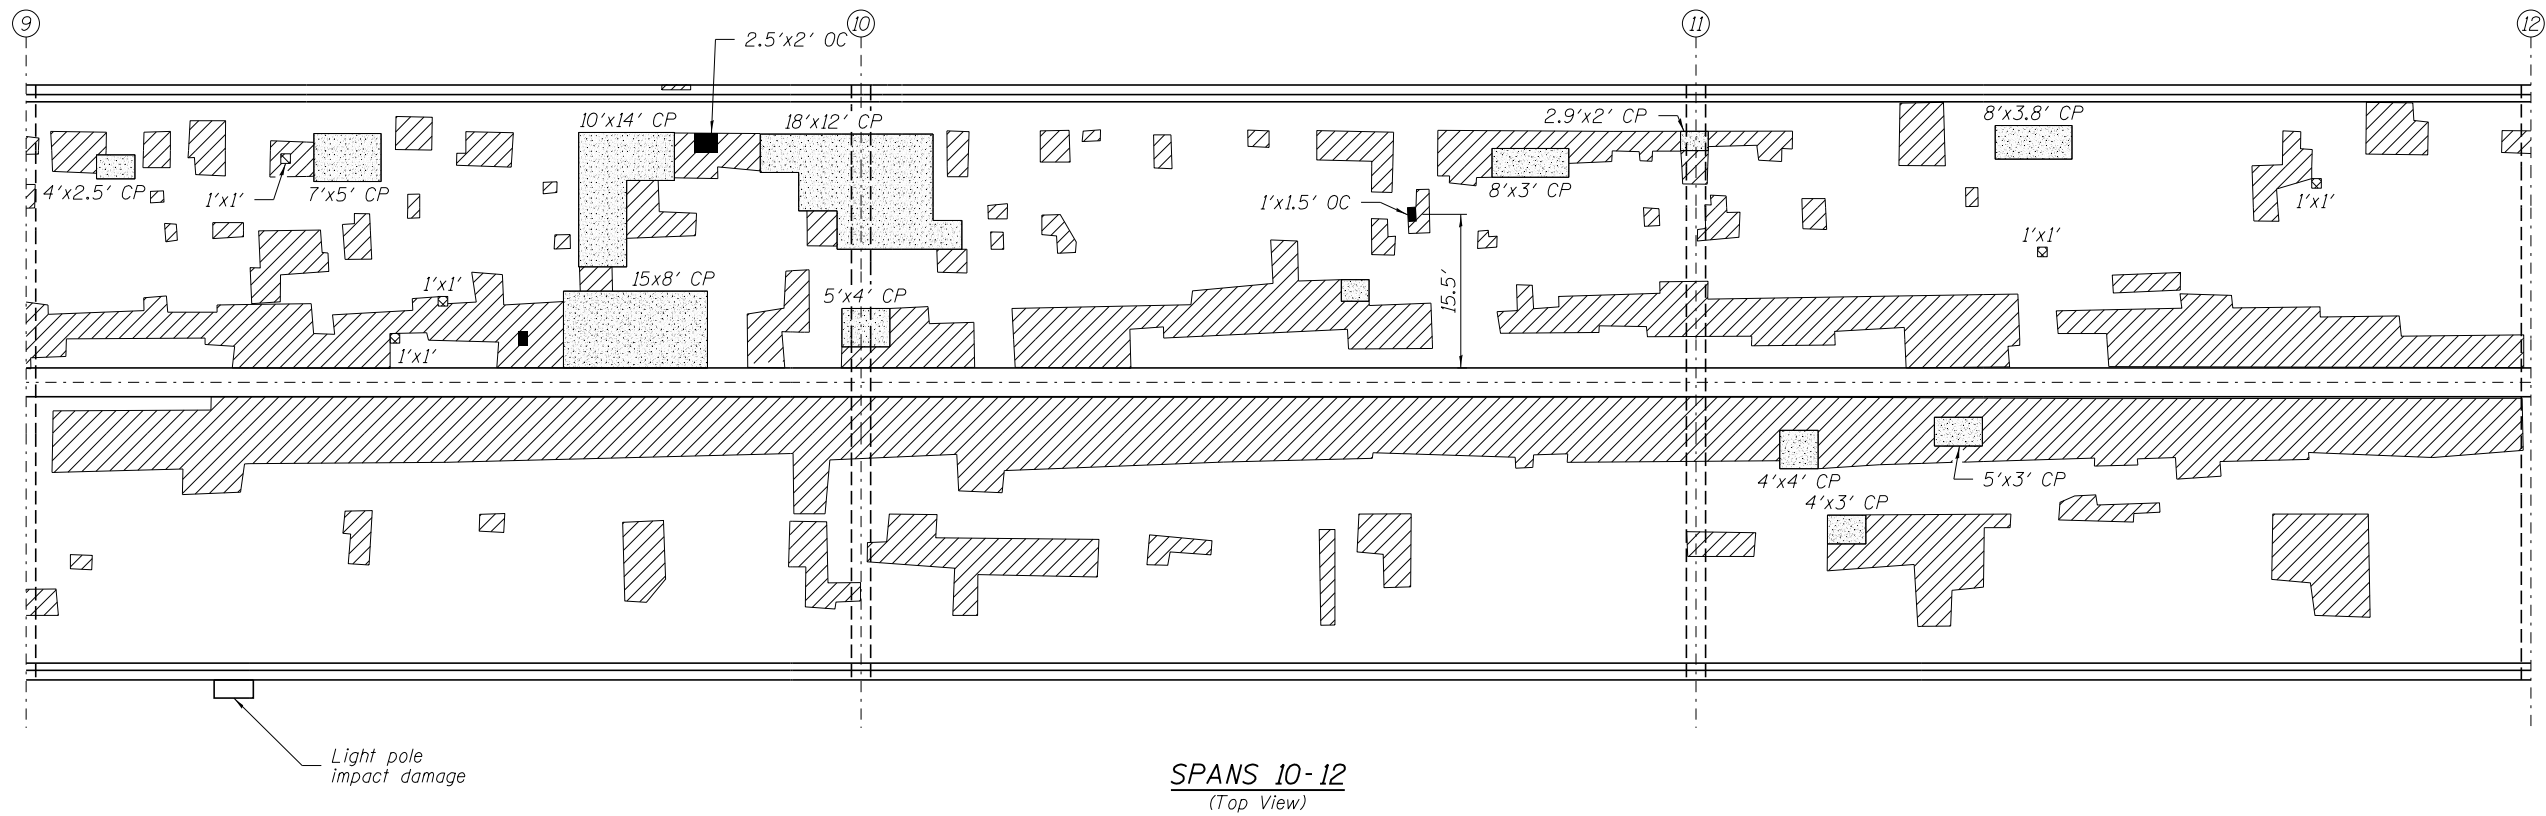
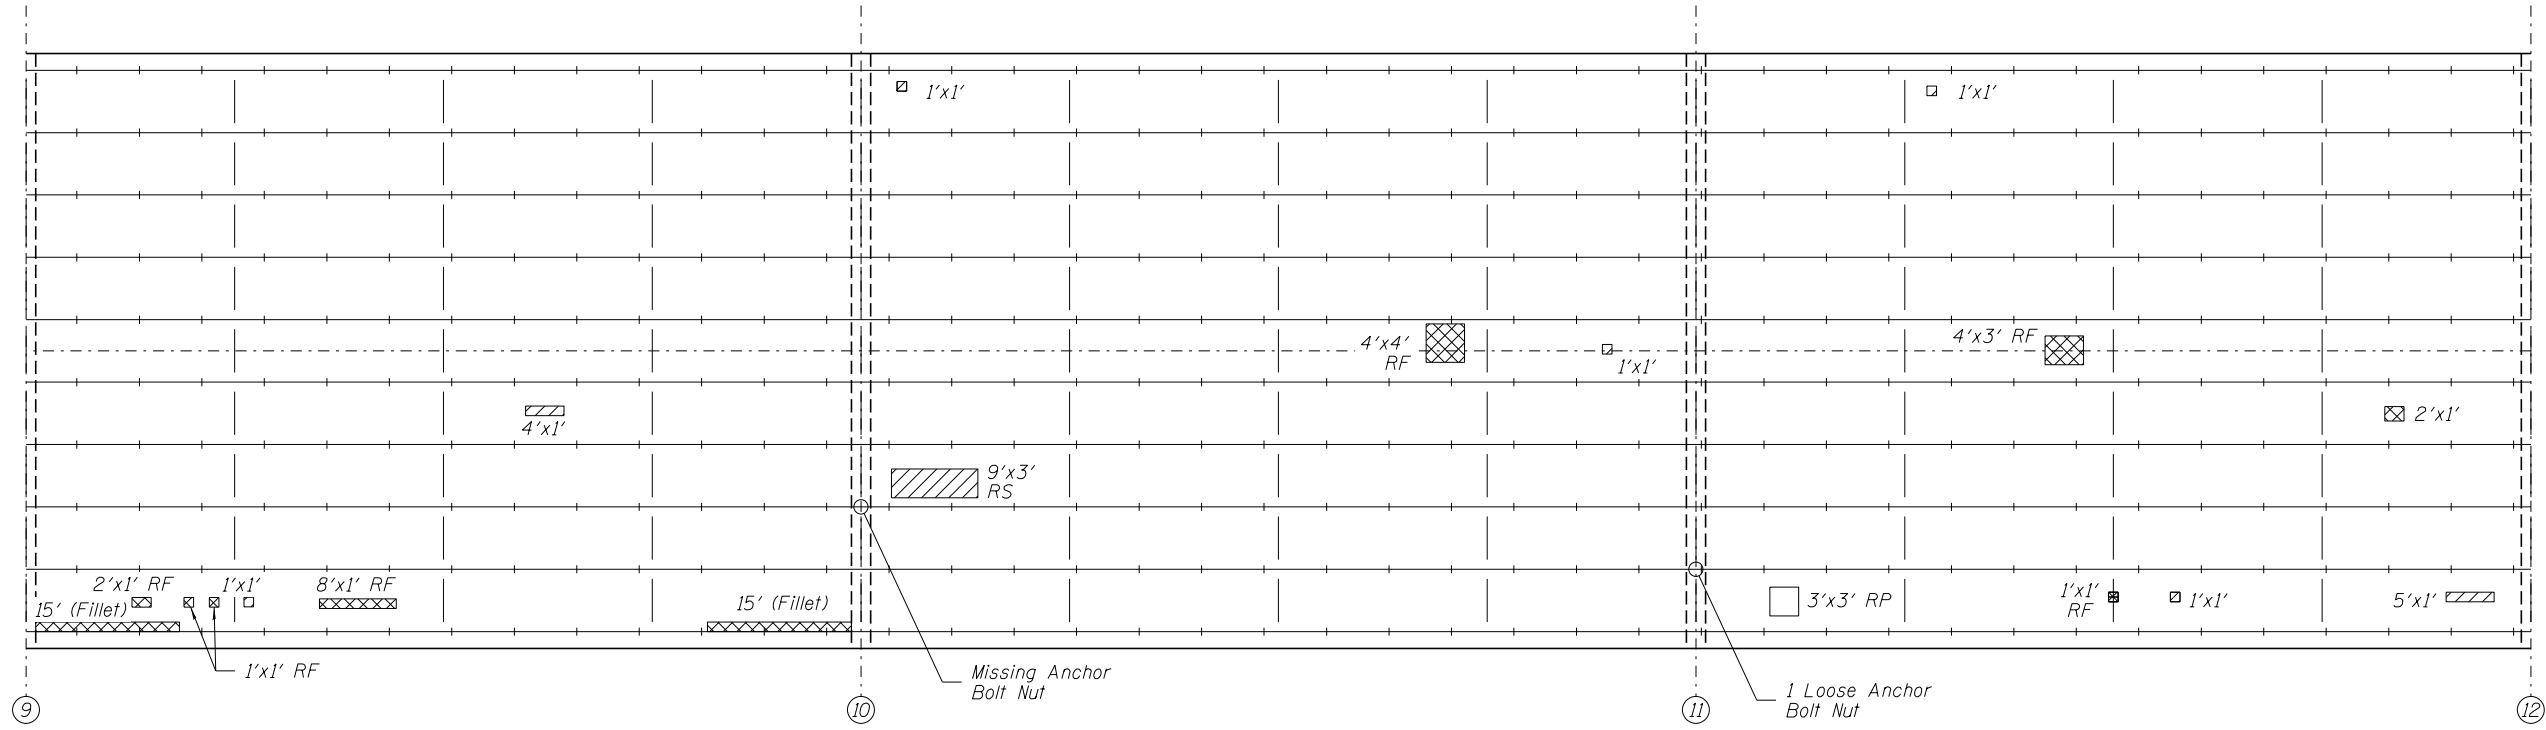
TOP/BOTTOM DECK SPANS 7-9
KIRK ROAD OVER UNION PACIFIC
RAILROAD AND REED ROAD
KANE COUNTY
STRUCTURE NO. 045-3096

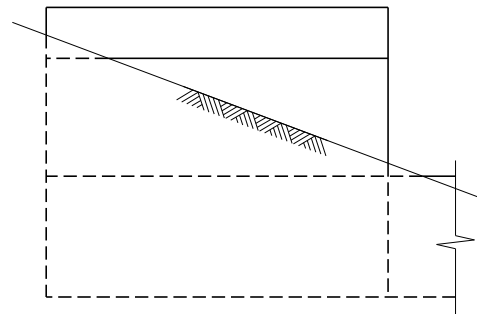
ELEVATION
(Looking West @ Wingwall)

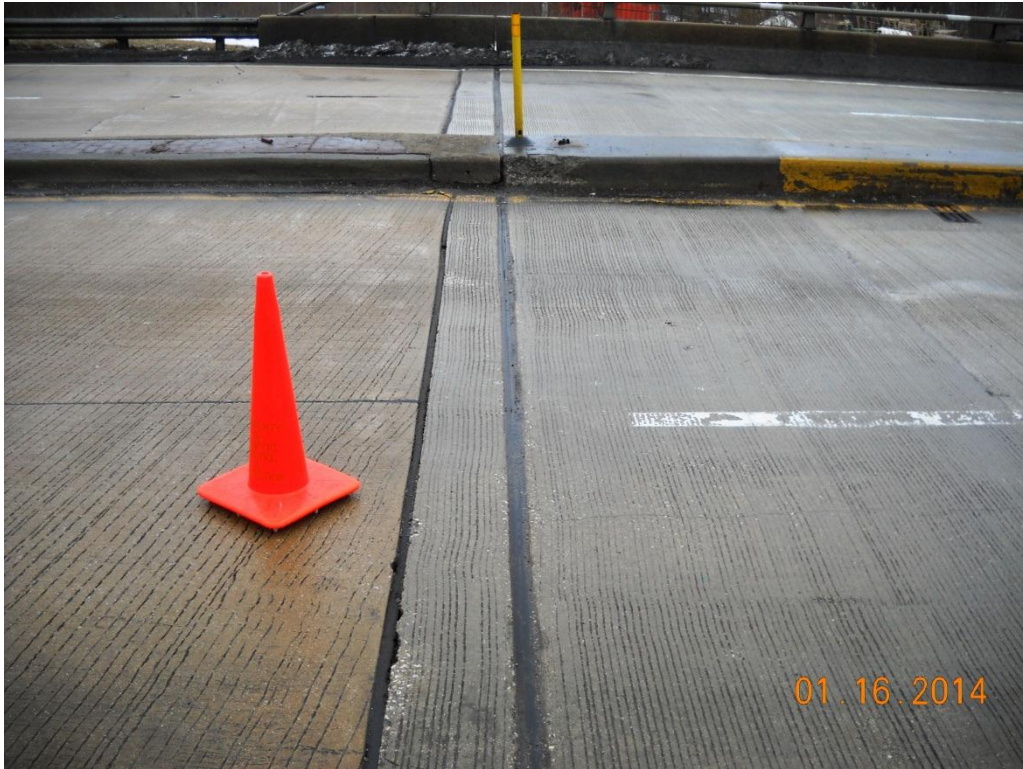
Photo No. 9
North abutment transverse joint, seal is leaking

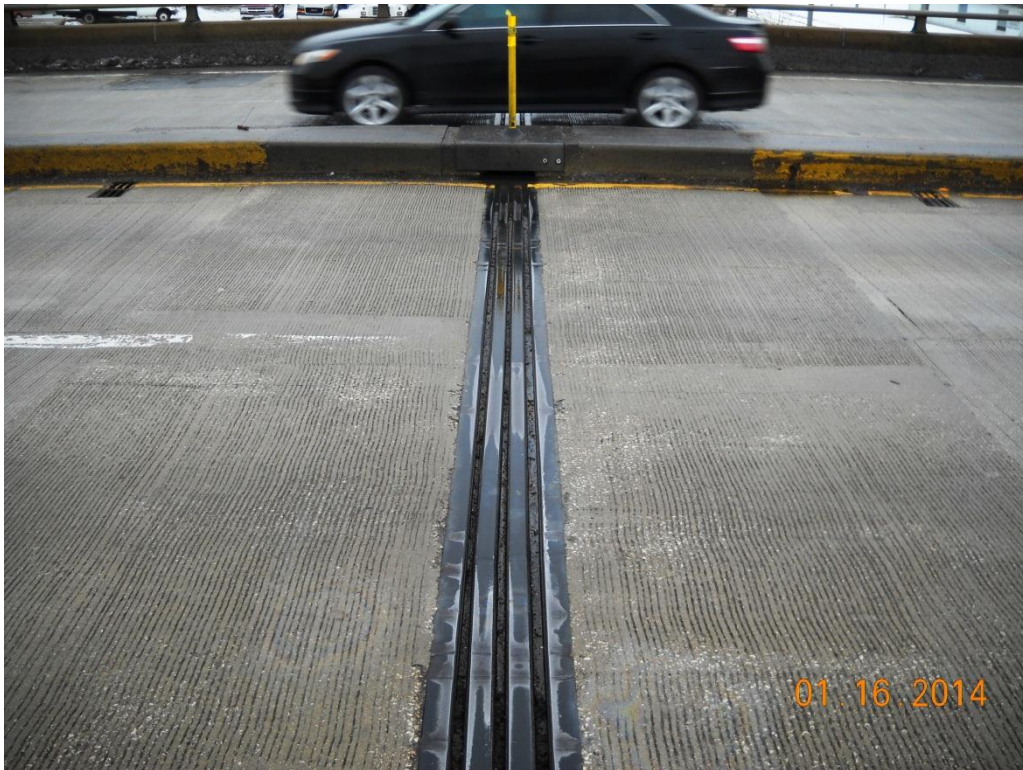
Photo No. 10
Pier 3 transverse joint

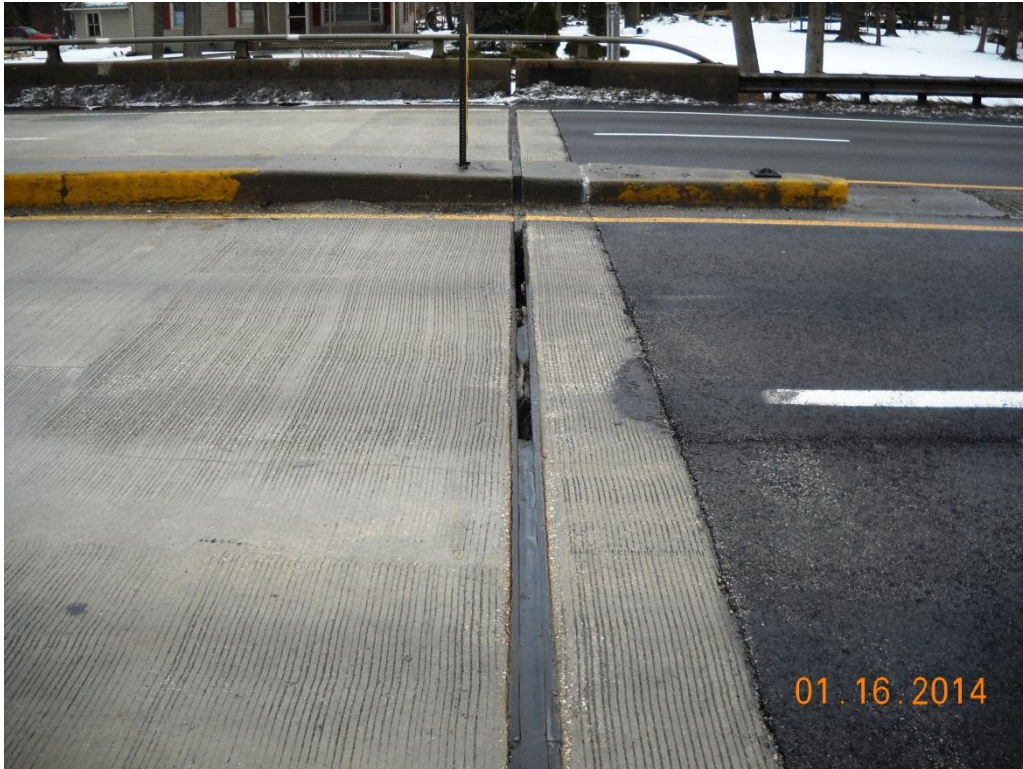
Photo No. 13
South abutment transverse joint, seal has failed

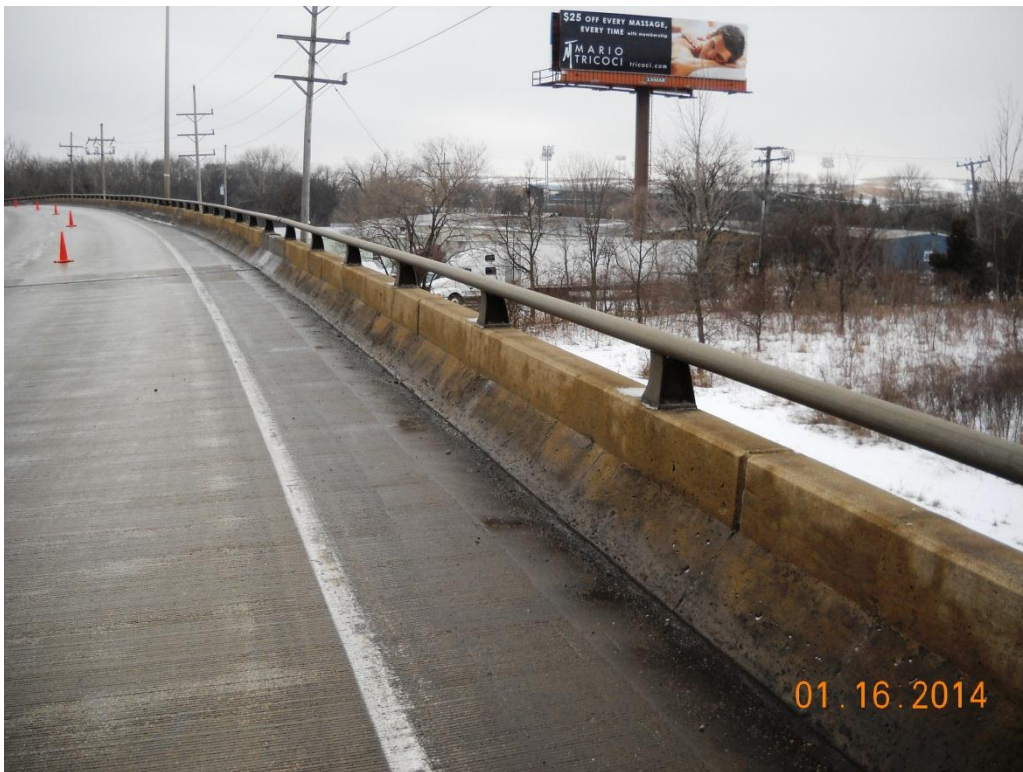
Photo No. 14
West parapet looking south

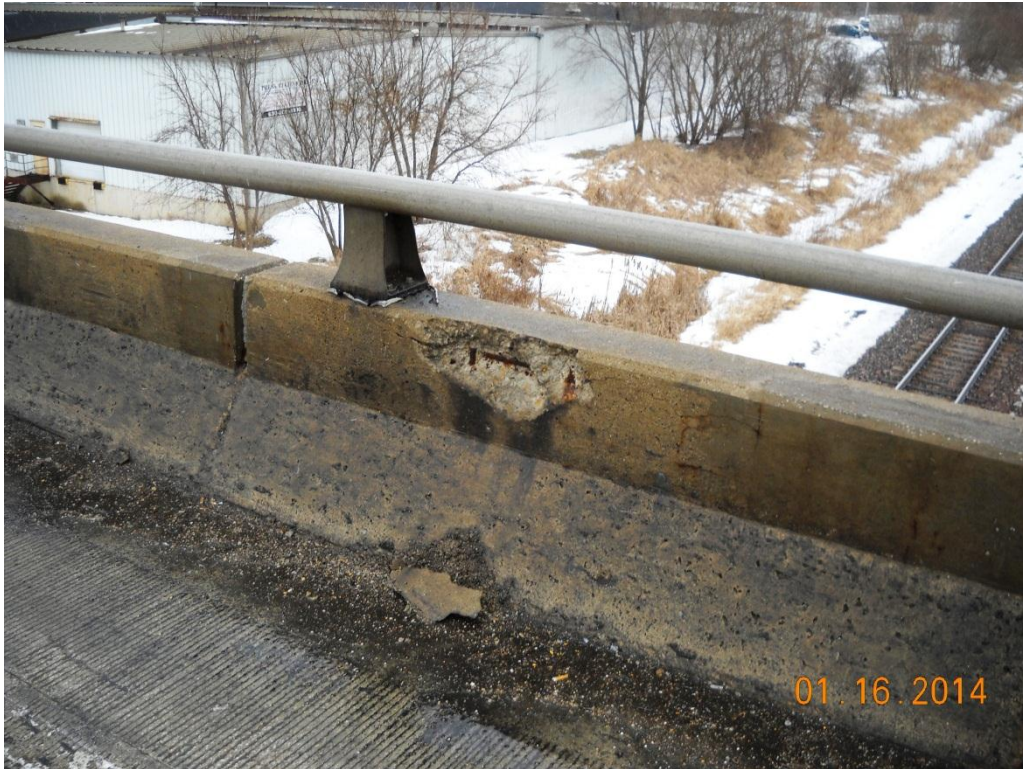
Photo No. 17
Spalled concrete on parapet - common

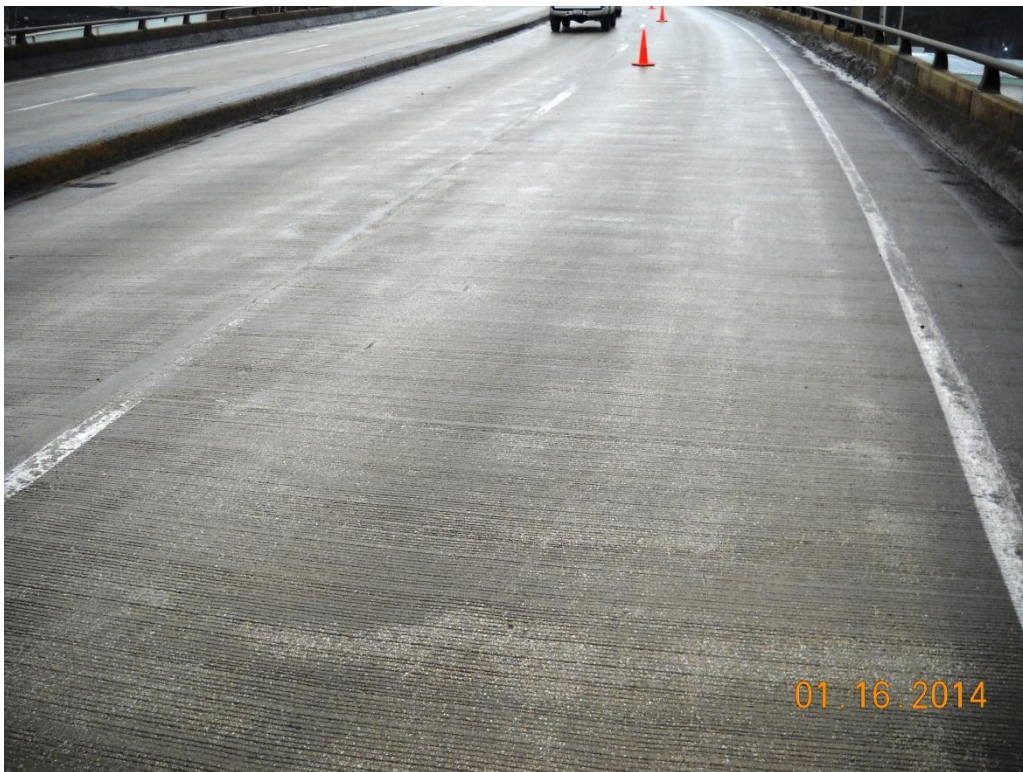
Photo No. 18
Top of deck, span 5 SB, looking south

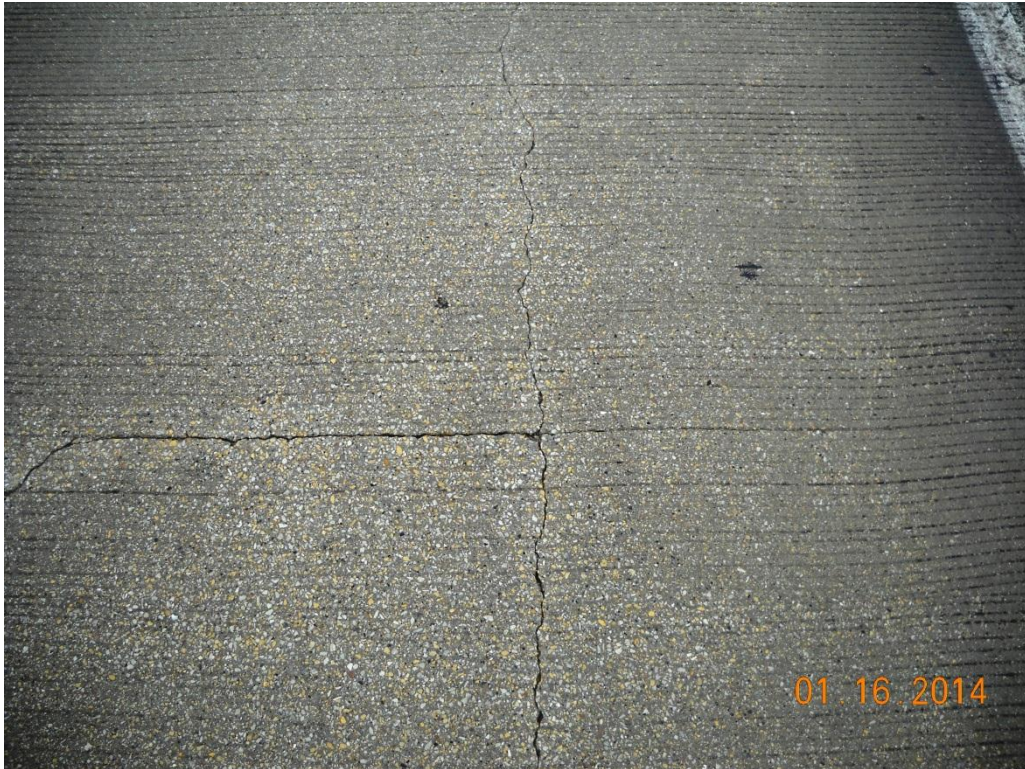
Photo No. 19
Top of deck, span 5 SB – intersecting open cracks in overlay (common)

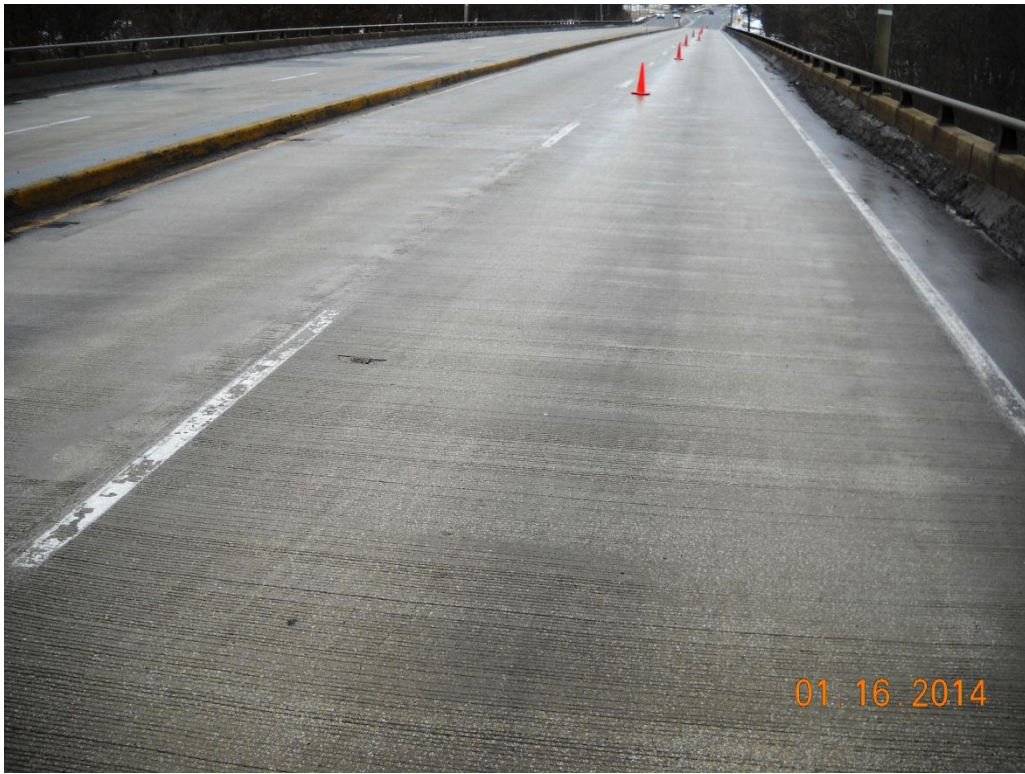
Photo No. 20
Top of deck, span 9 SB, looking south

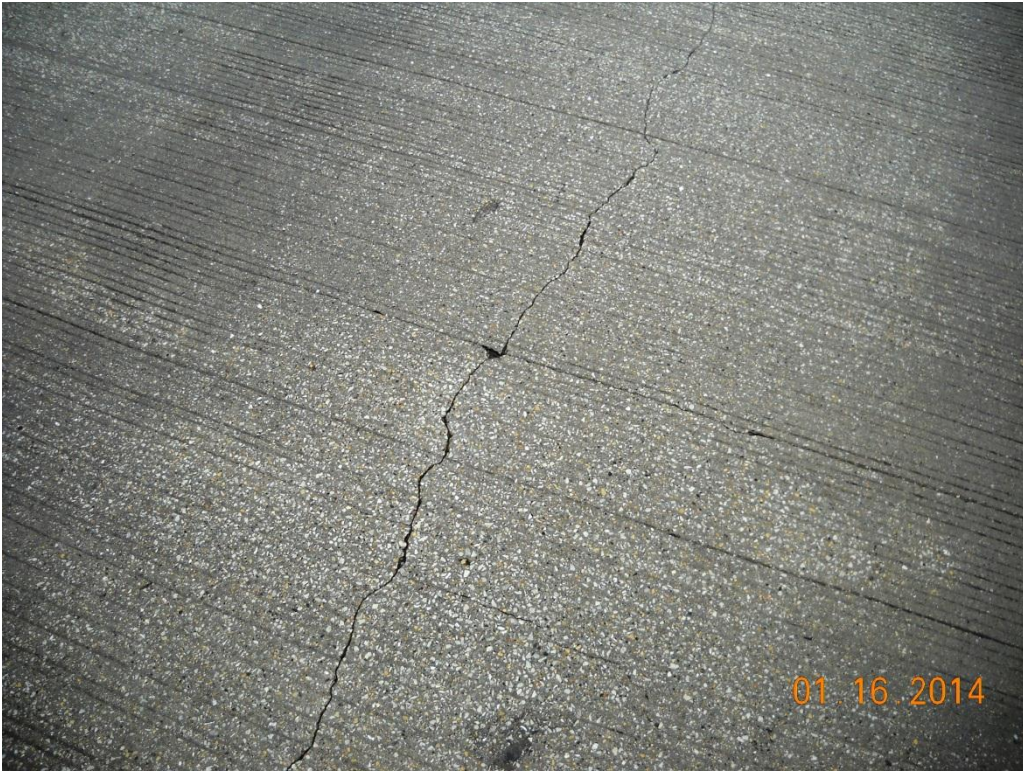
Photo No. 21
Top of deck, span 9 SB – open cracks in overlay (common)

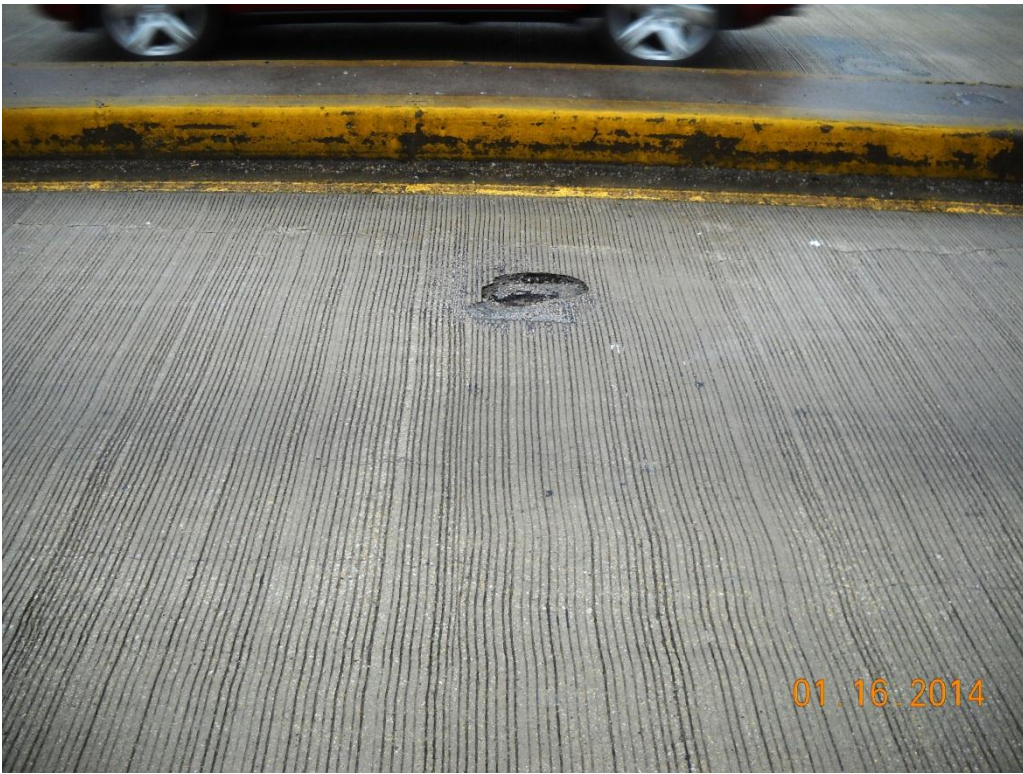
Photo No. 22
Top of deck, span 16 SB - spall

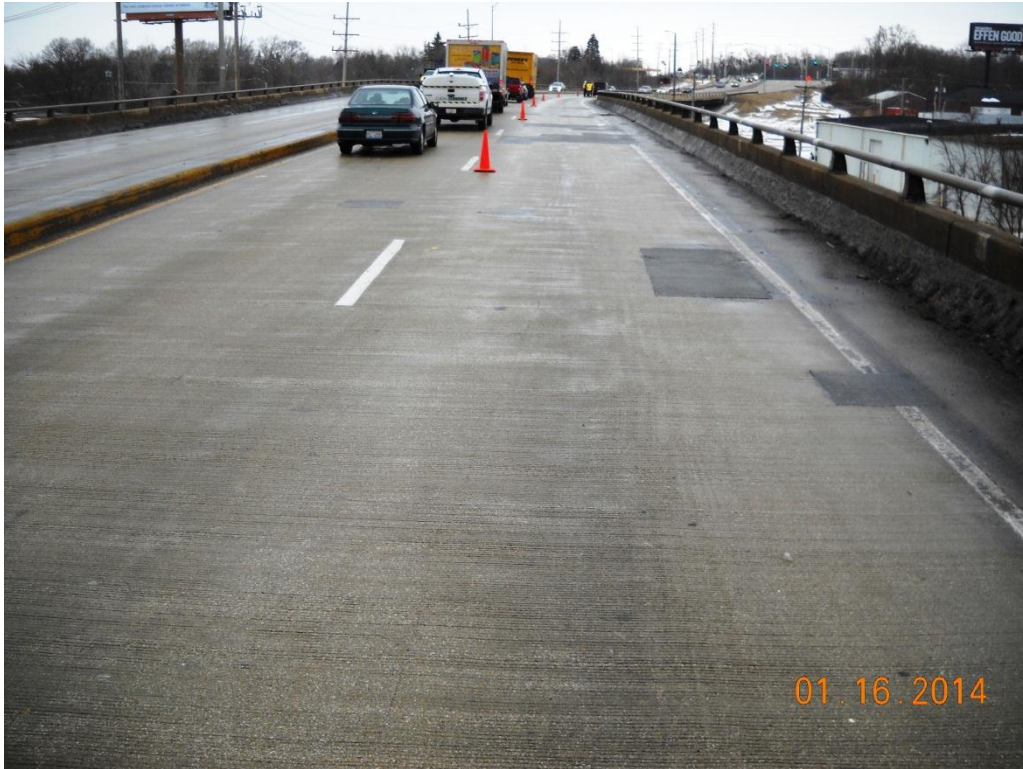
Photo No. 23
Top of deck, span-8 NB, looking north

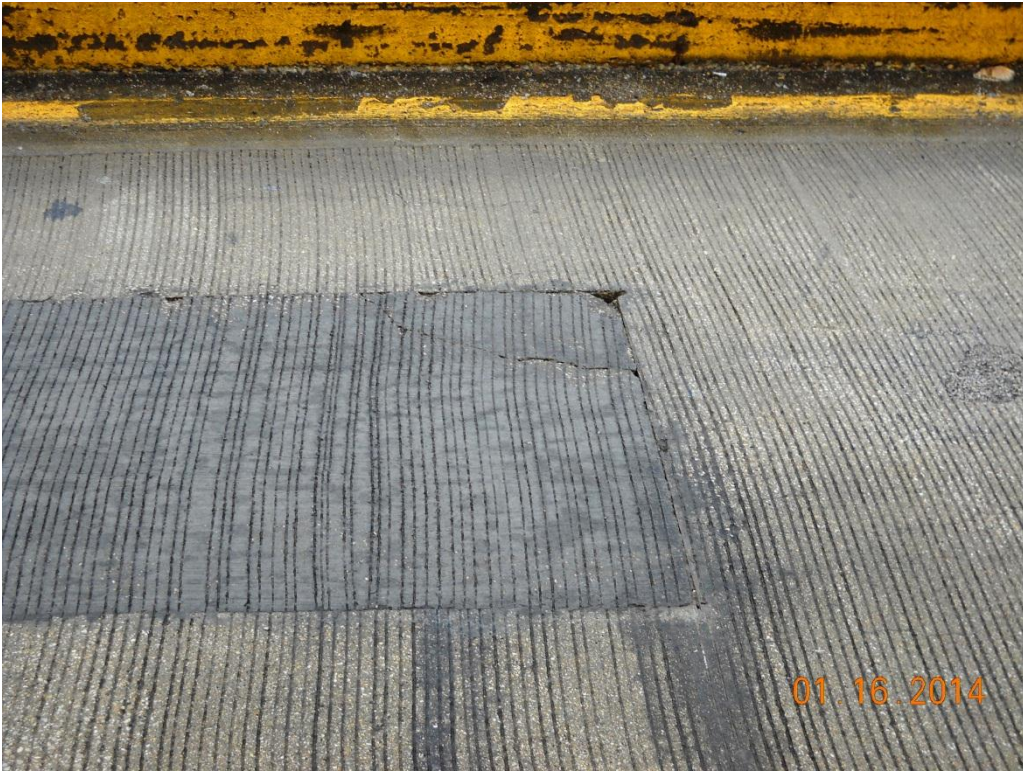
Photo No. 25
Top of deck, span-7 NB, damaged concrete patch

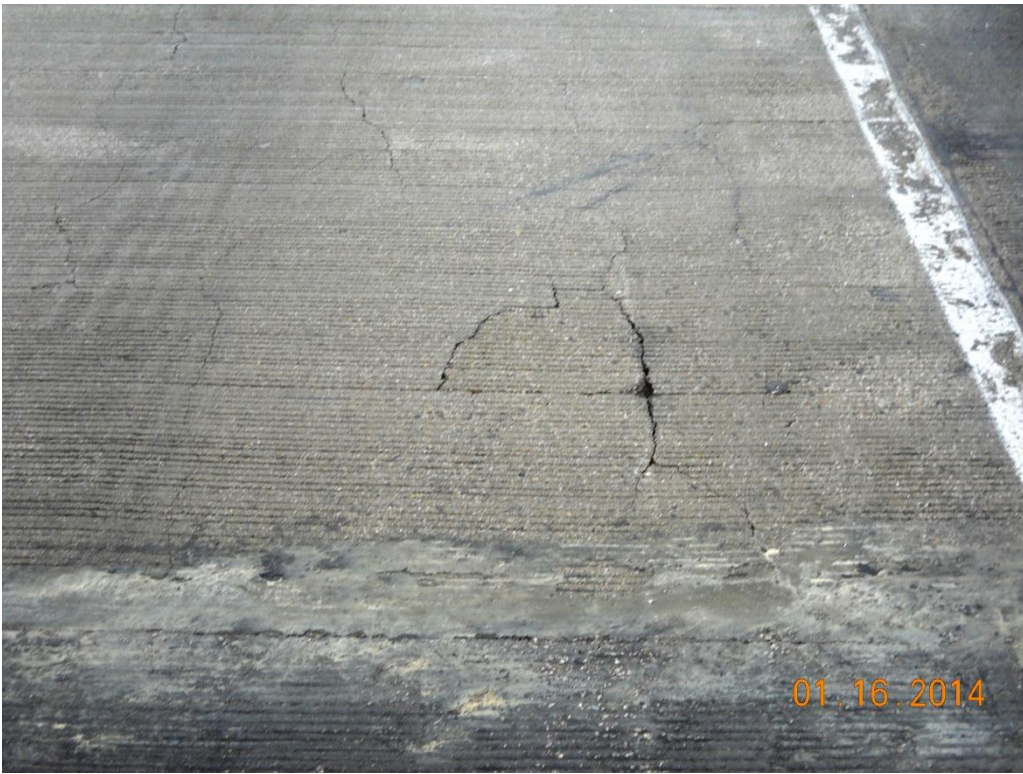
Photo No. 26
Top of deck, span-3 – intersecting open cracks in overlay

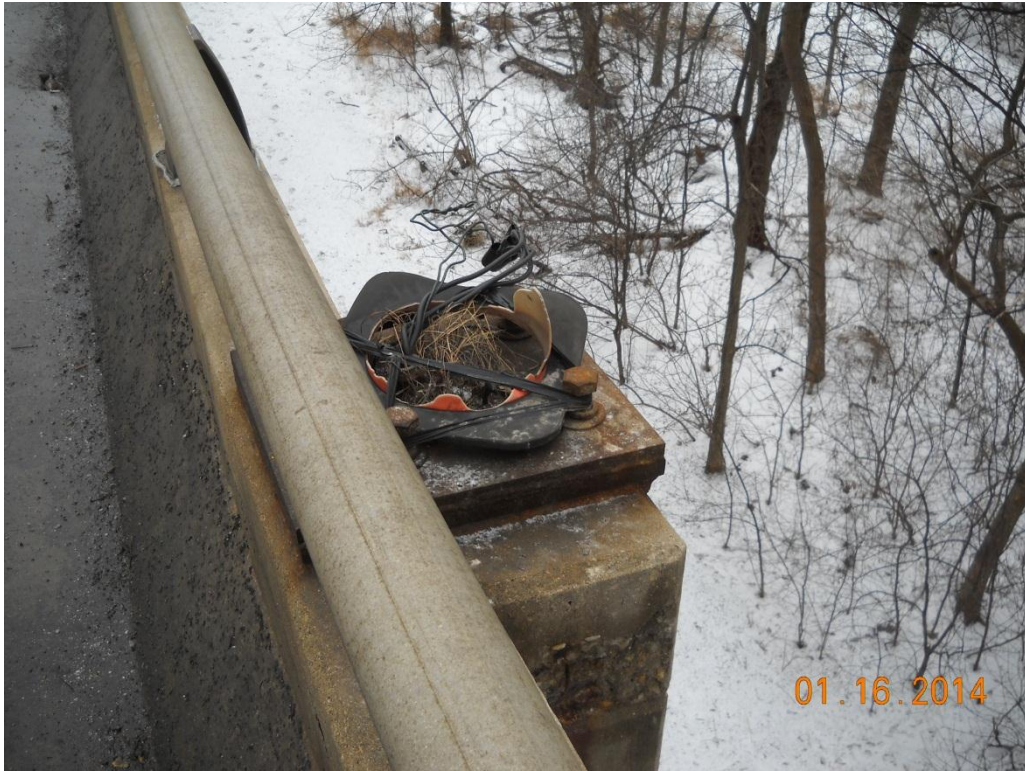
Photo No. 27
Missing light pole, span-14, west side

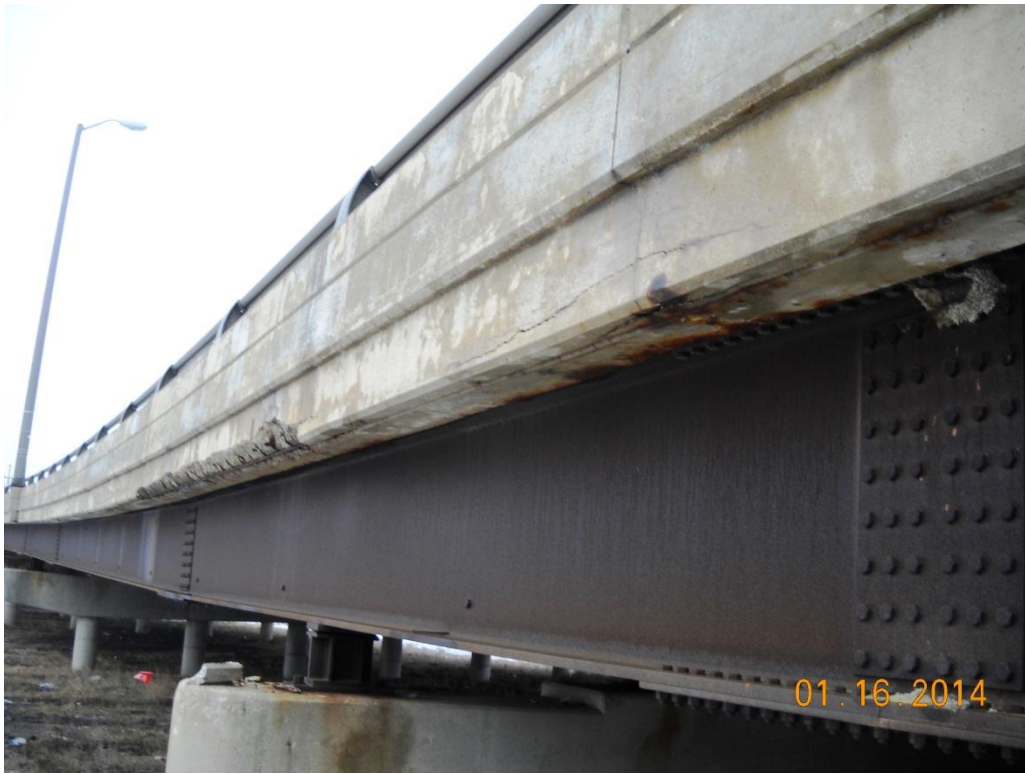
Photo No. 28
West deck fascia – typical condition, looking SW

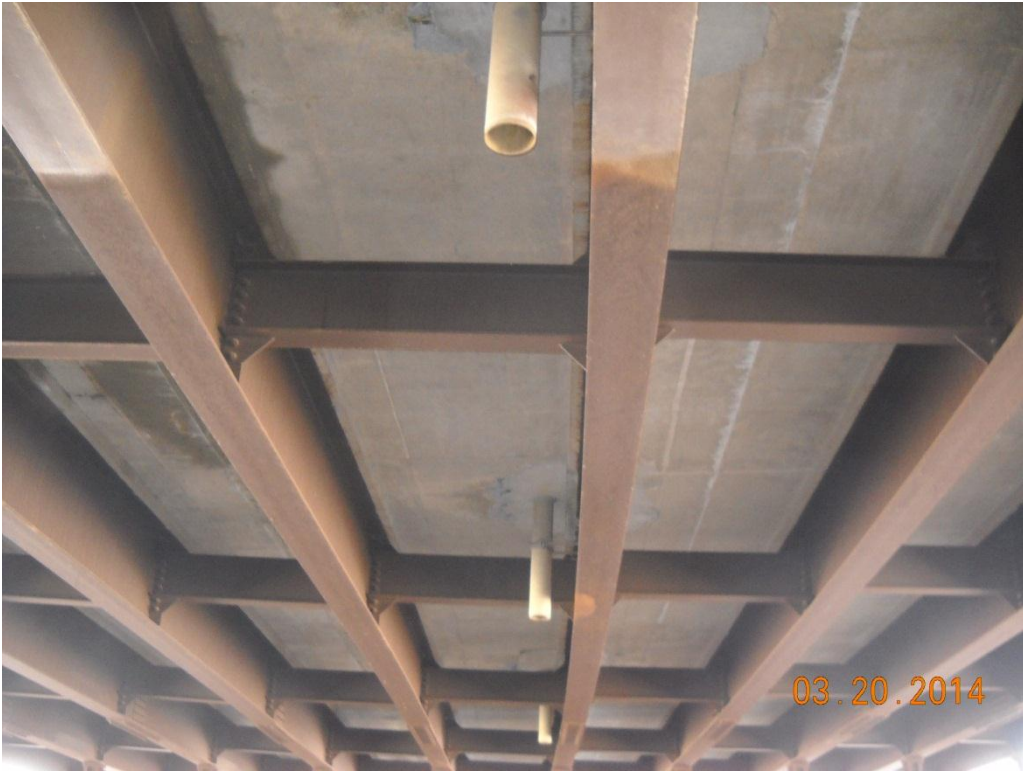
Photo No. 29
Bottom of deck and beams, span-4 – center bays, looking south

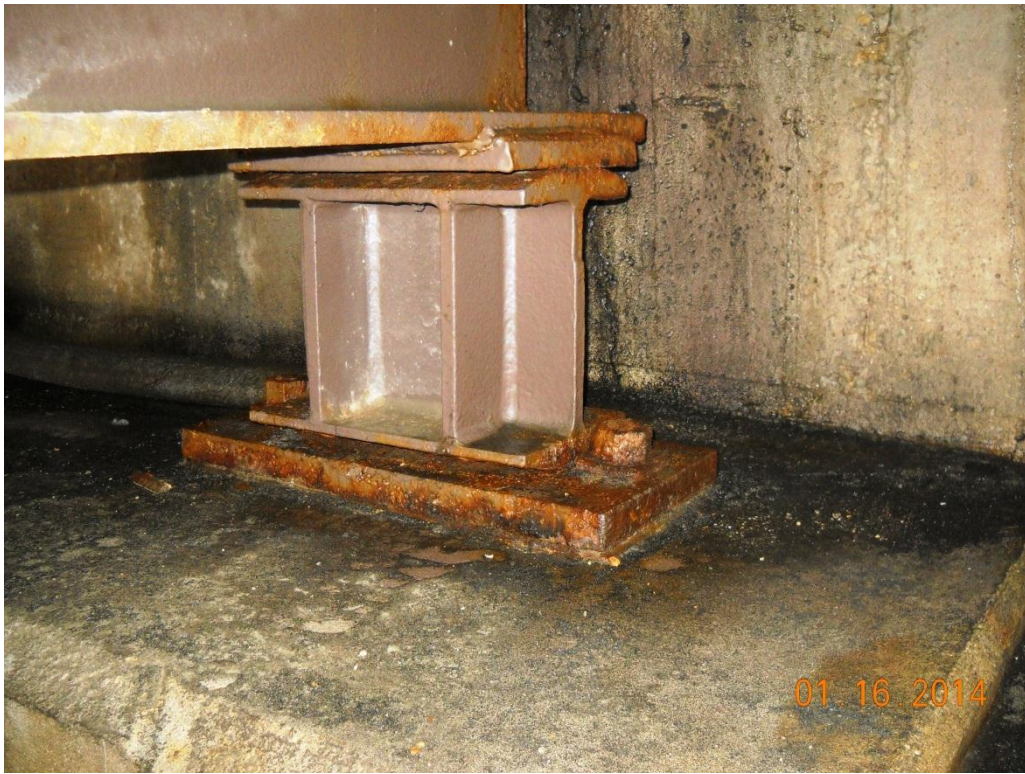
Photo No. 36
Expansion bearing at north abutment – typical condition

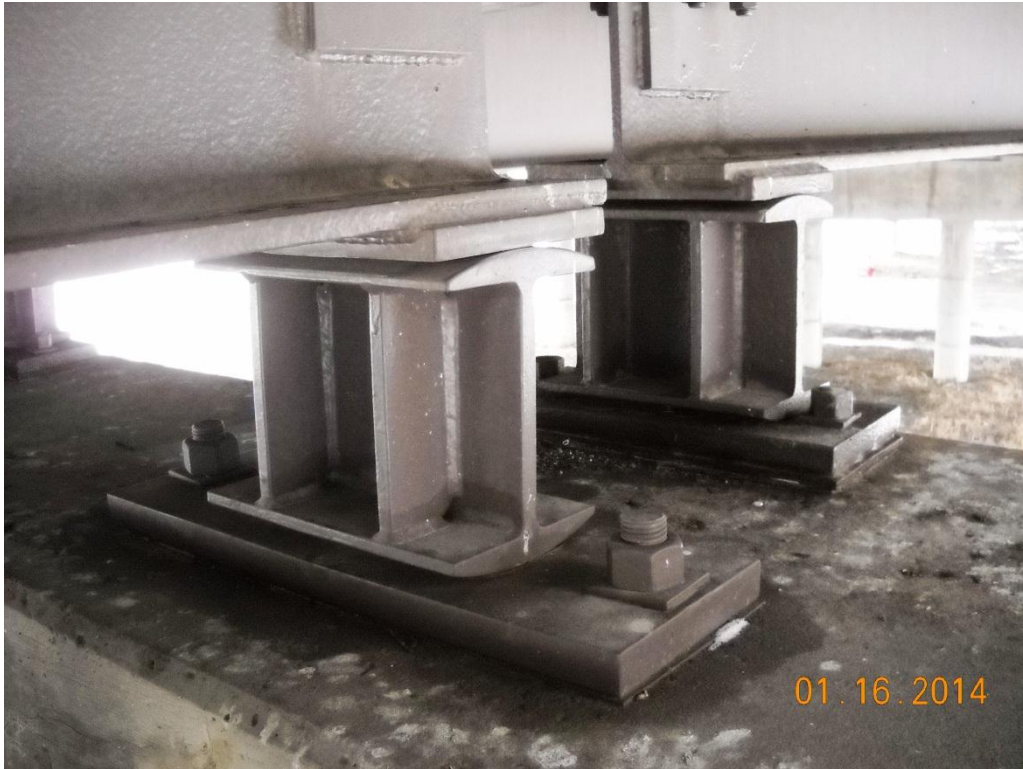
Photo No. 37
Expansion bearings at Pier-3, typical condition beneath interior transverse joints

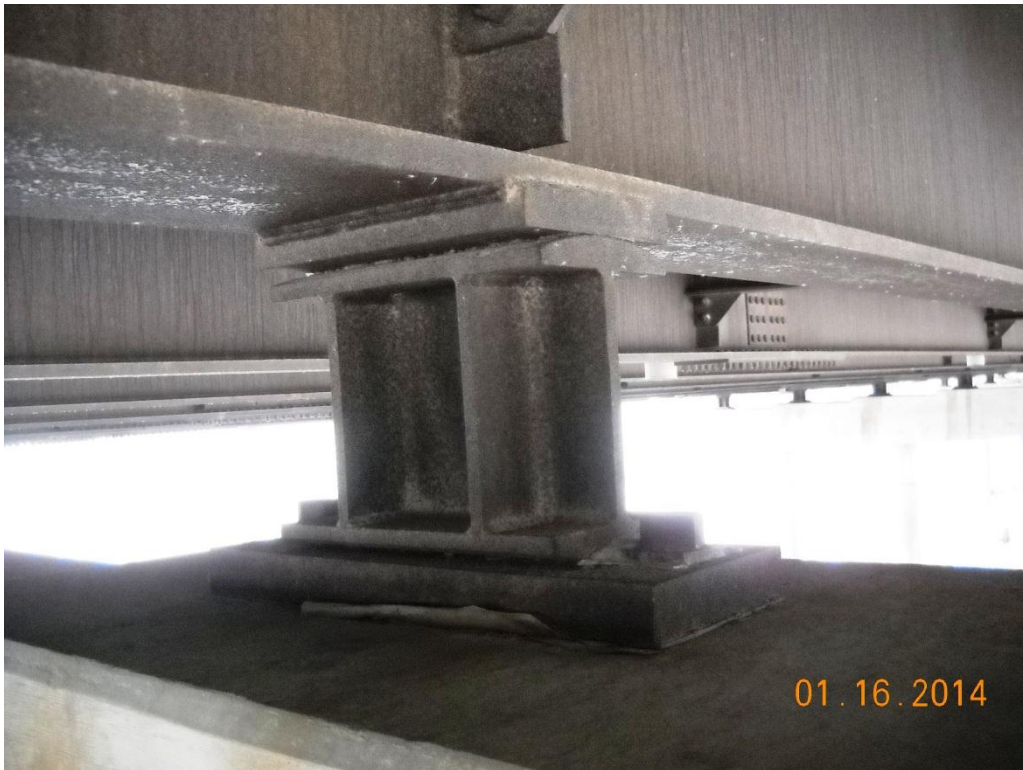
Photo No. 38
Expansion bearing at Pier-5, typical condition beneath continuous deck locations

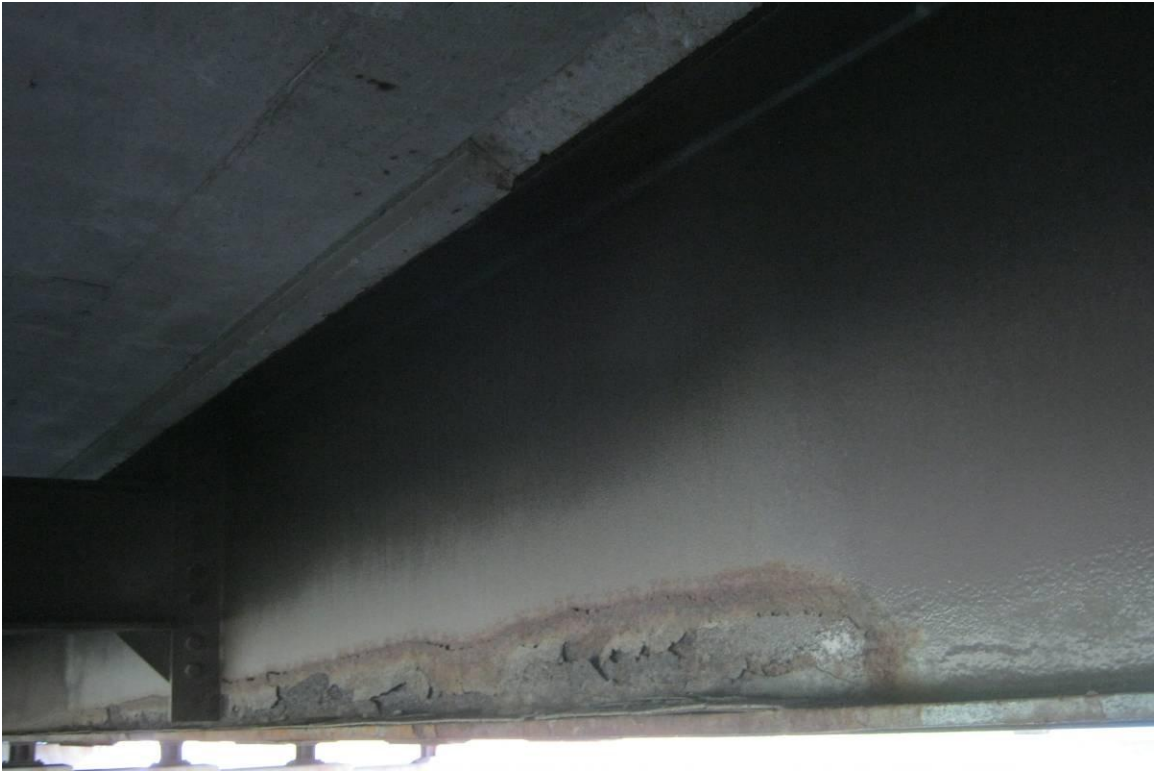
Photo No. 39
Corrosion on web and bottom flange on Beam-6 from west side near Pier 3
