Abbreviated Bridge Condition Report

REGION / DISTRICT: 1 / 1

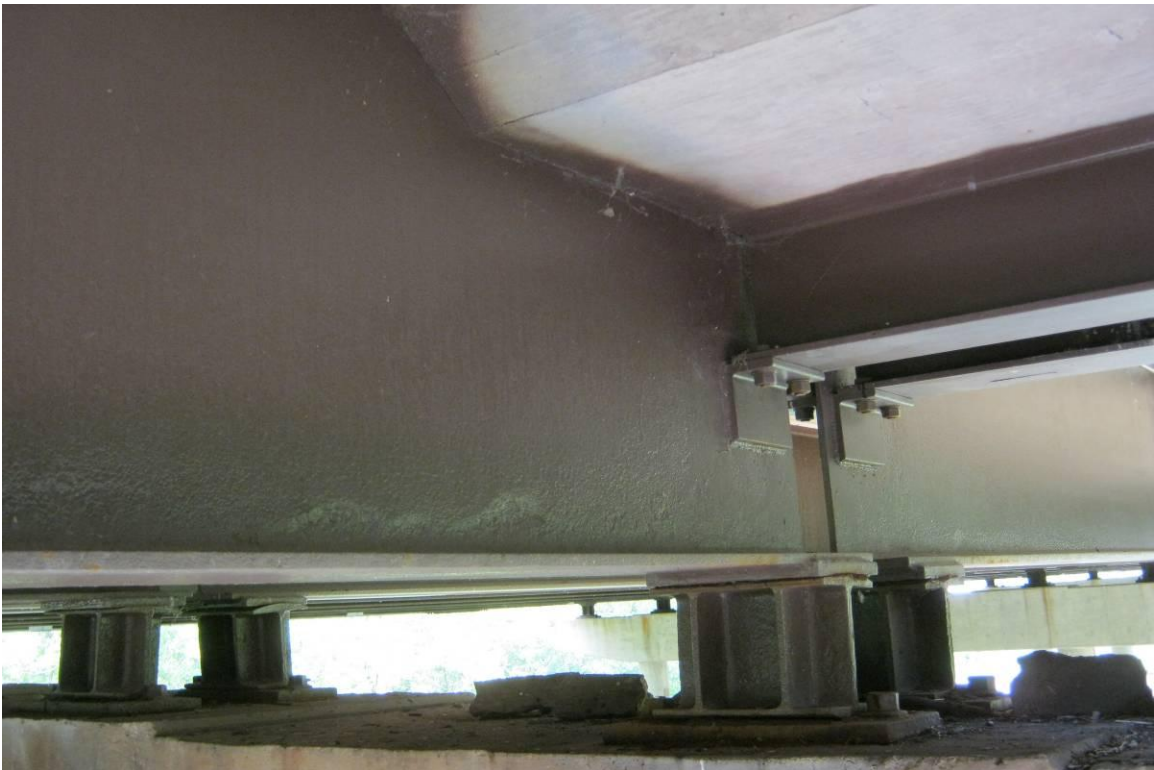
Photo No. 40
Typical pitting of web near Pier-13

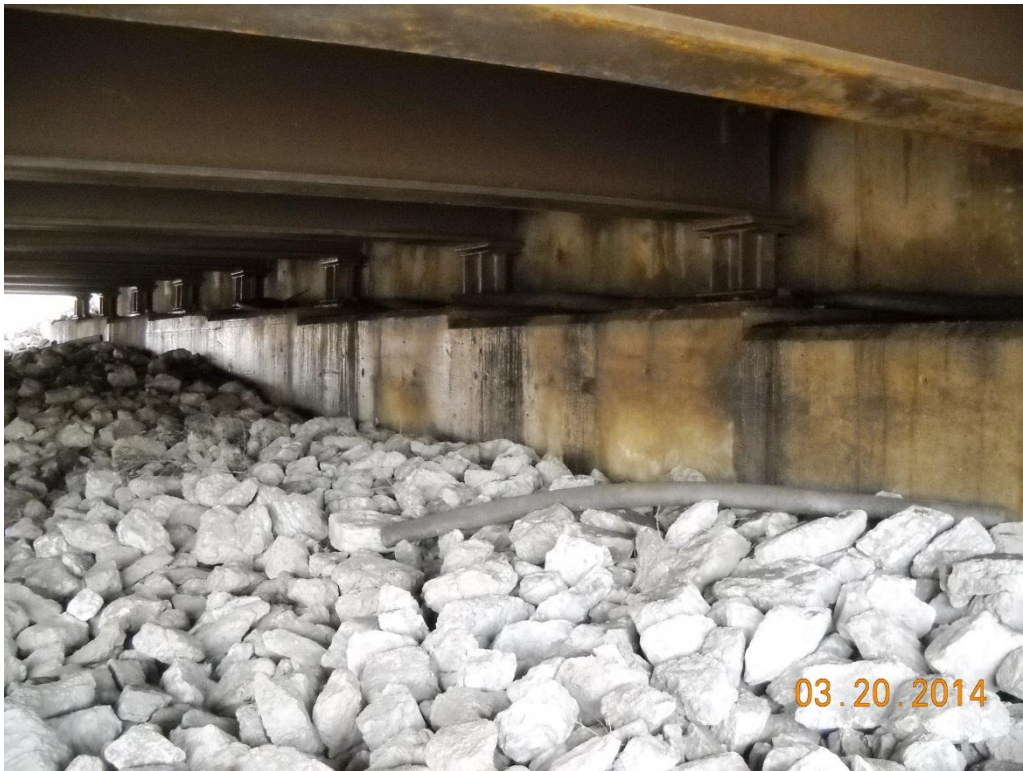
Photo No. 41
Abutment cap – typical condition

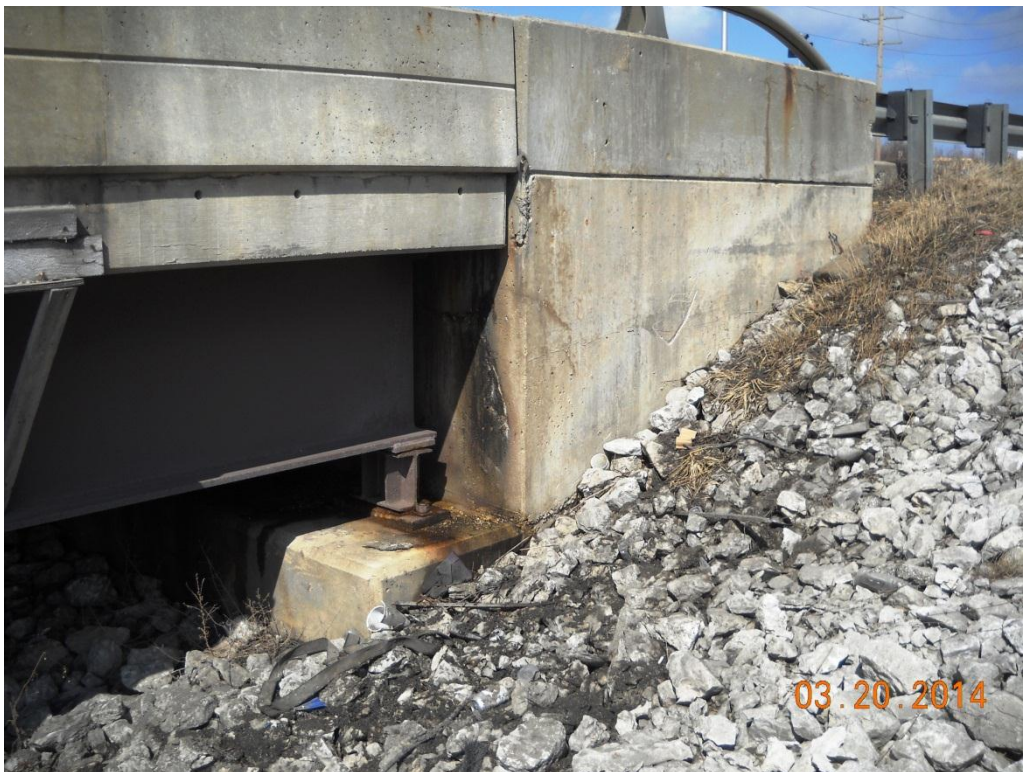
Photo No. 42
NE abutment wingwall

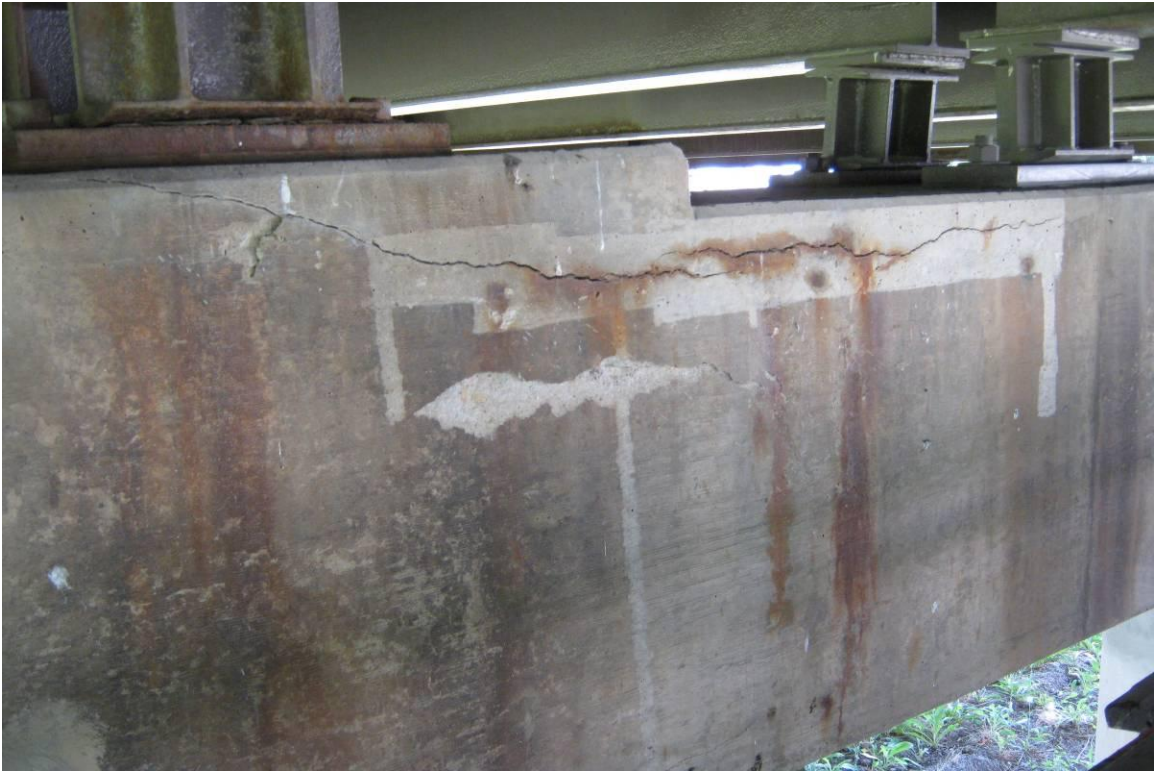
Photo No. 45
Pier 3, looking SW, cracking and delaminations common in cap

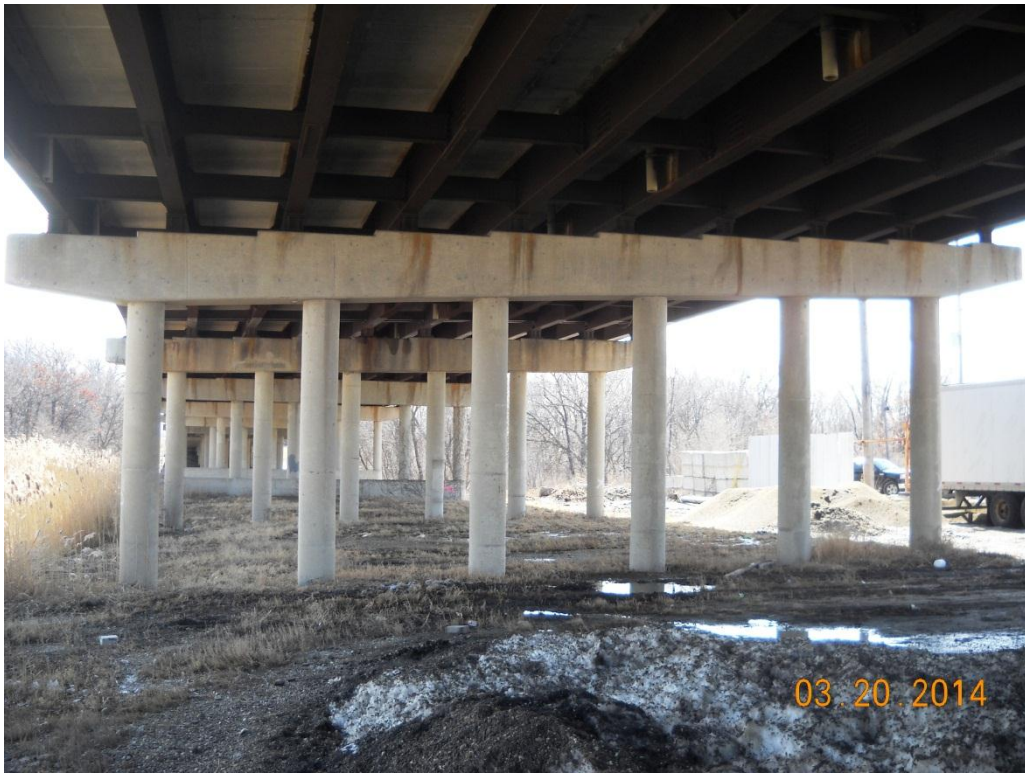
Photo No. 46
Pier 7, looking south (typical pier condition without transverse deck joint)

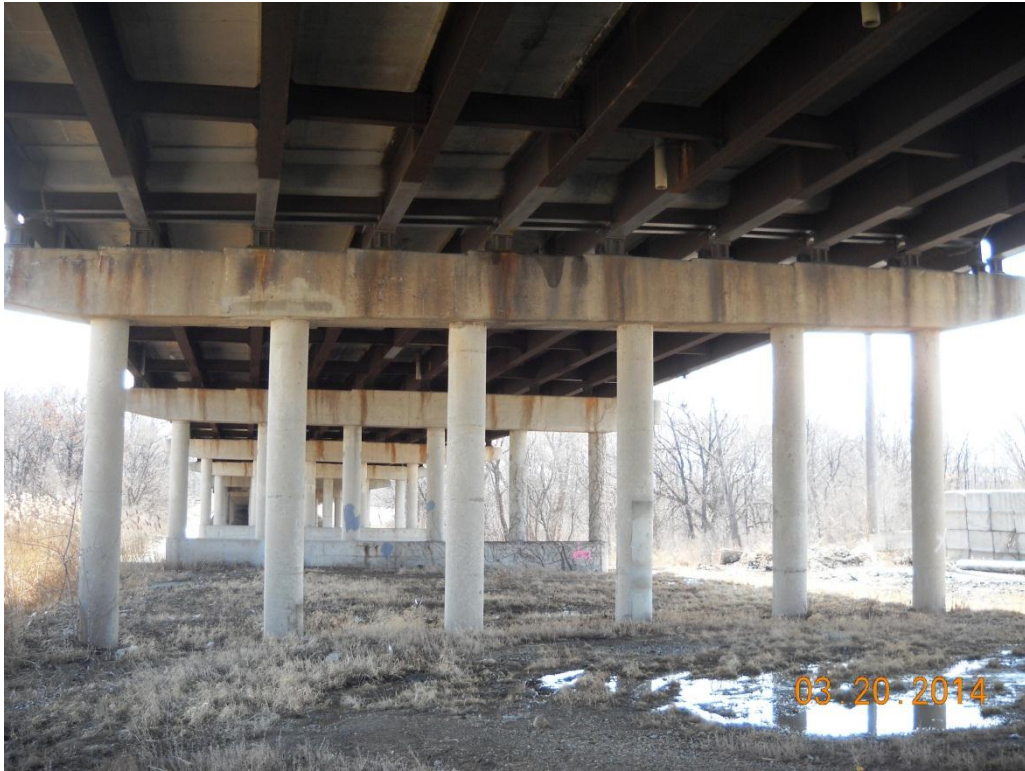
Photo No. 47
Pier 8, looking south

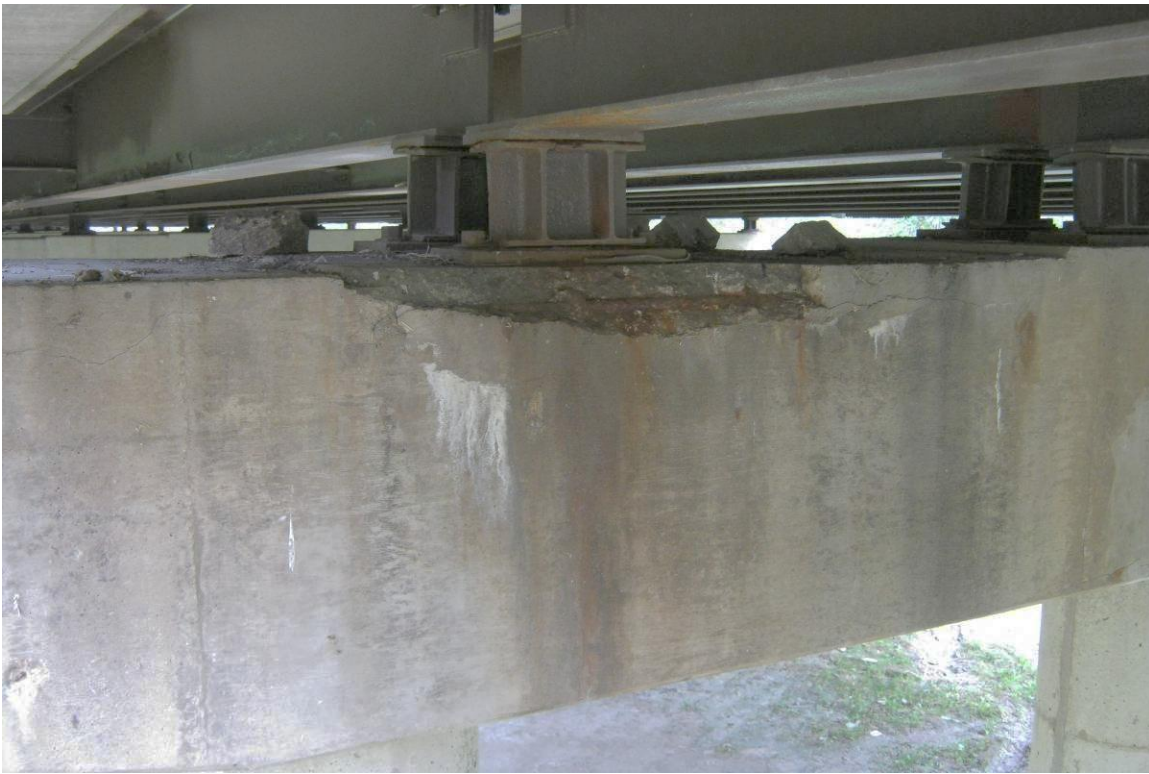
Photo No. 50
Pier 13, east end looking south, spalling and delaminations common in cap
